ASIA TURBOMACHINERY & PUMP SYMPOSIUM
MARCH 2018 | SUNTEC SINGAPORE

Rotor magnetization in Turboexpander and its effect on Vibration readings

Case Study- Turboexpander in Ethylene Plant

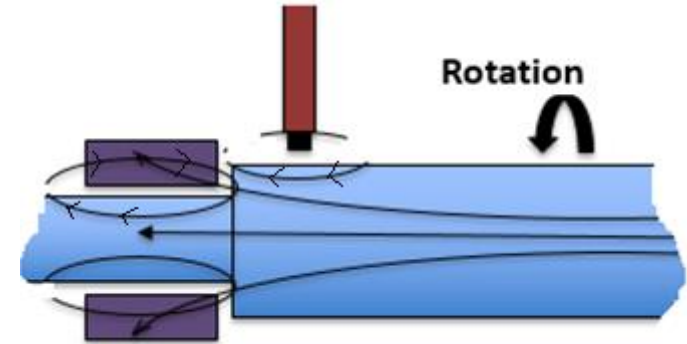
Illustration: Magnetically induced current in a Rotor

- In a magnetized rotating machinery, relative movement between stator and rotor in presence of magnetic field produces eddy and circulating currents.
- These currents form an internal loop. Such current loops reinforce the magnetic field, which further increase the induced current generation.
- The induced current affects readings from a conventional eddy current vibration probe.

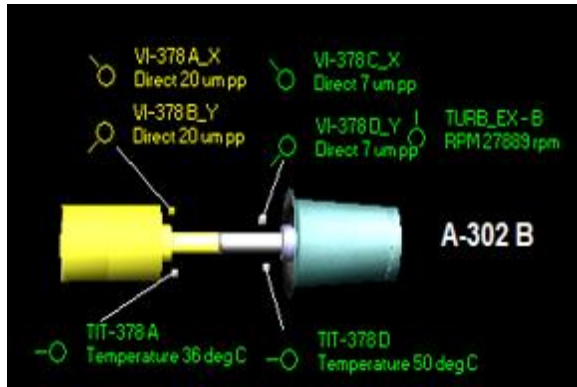
Expander Compressor unit

Expander speed: 44,000 RPM

Loaded by centrifugal compressor

Power: 250 KW

Commissioned in 2009

- Expander is used for isentropic expansion of tail gas for recovery of ethylene and process refrigeration (-150 deg C)).
- This unit was operating with degraded performance for last one year resulting loss in ethylene production of about 4MT/ day.
- It was decided to overhaul and replace all worn out internals to recover expander efficiency.
- Expander assembled with new internals with OEM specified clearances.
